**HARD BARGAIN SURVEY**  
SAN SALVADOR, BAHAMAS, FEBRUARY 2004  
PREPARED BY: CARIBBEAN VOLUNTEER EXPEDITIONS (C/VE)  
VOLUNTEERS: S. RICE, A. AS CALLAWAN, R. GARBARK,  
R. HIRSCHMAN, J. MILLER, E. AM. ROBERTS, J. WILKINDE

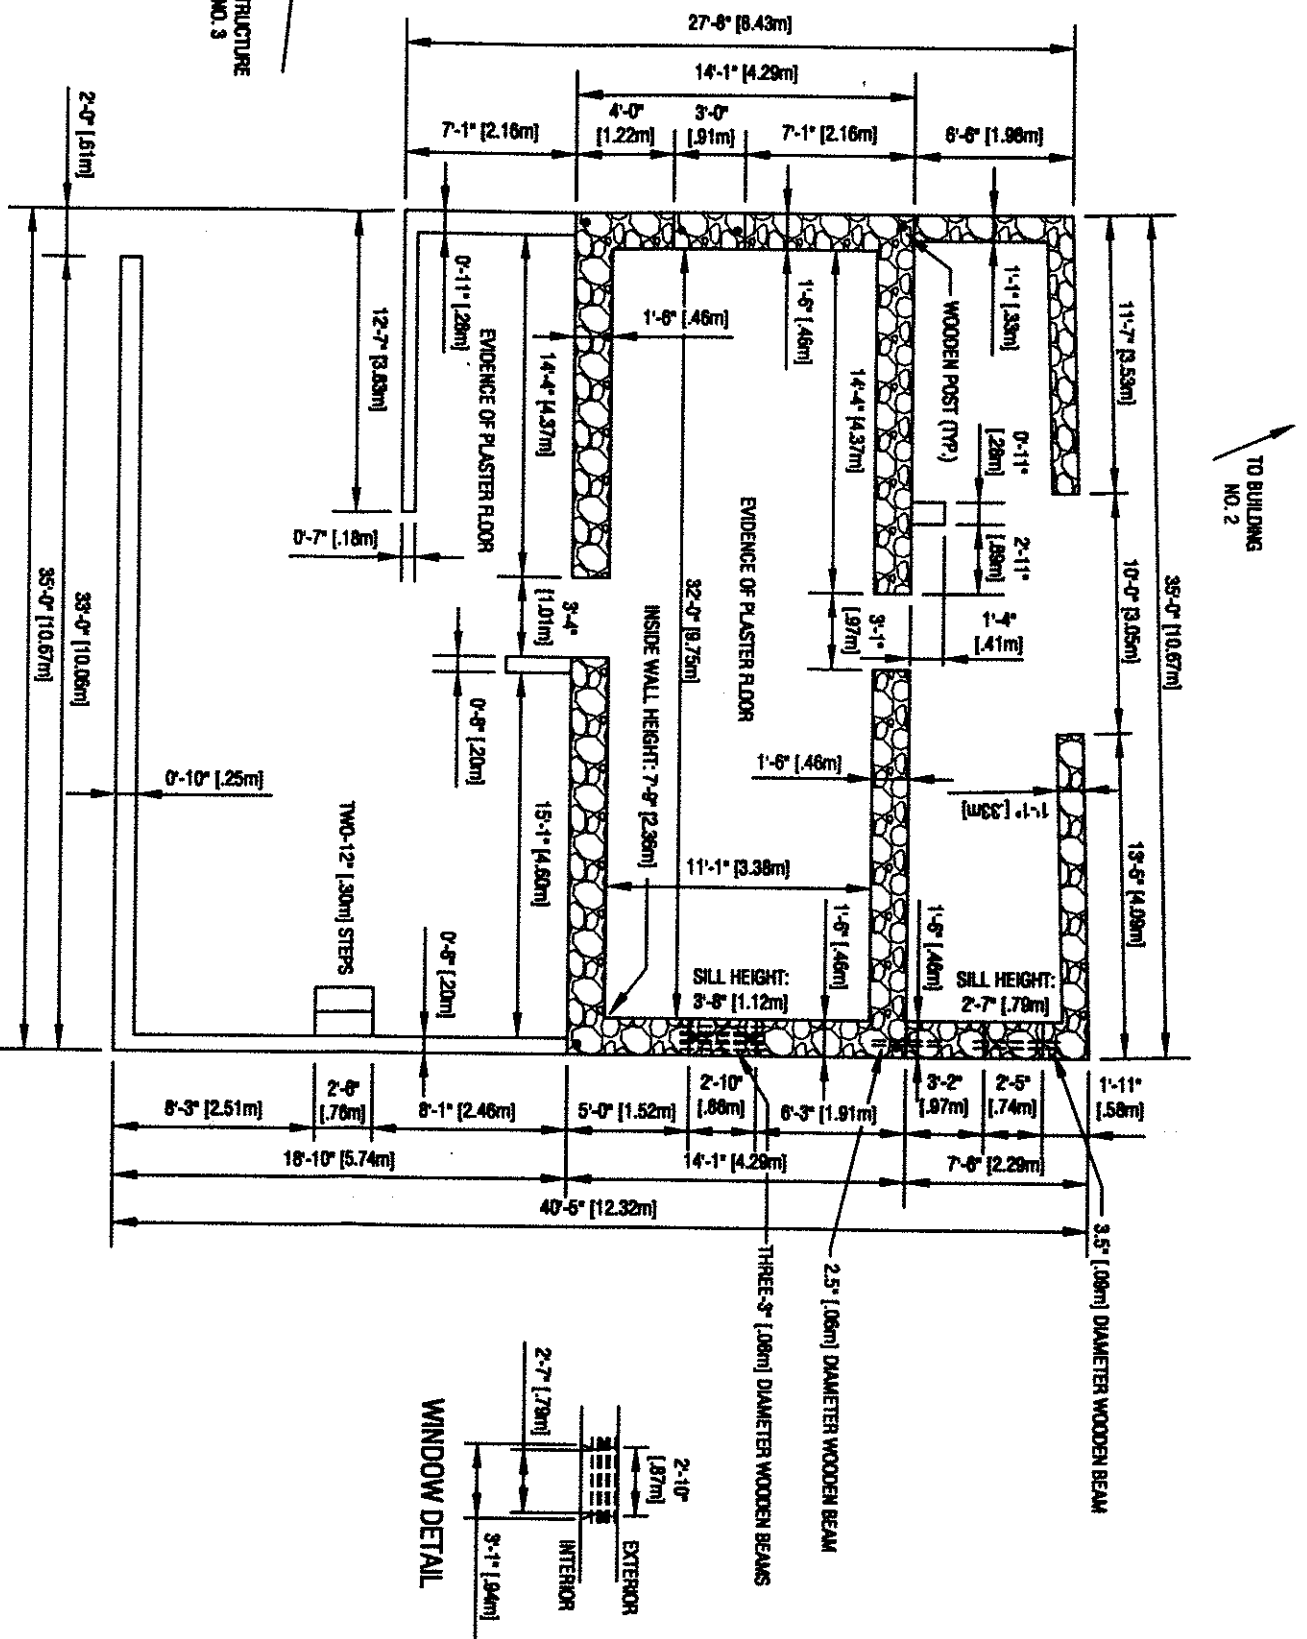
**BUILDING NO. 1**  
SCALE: 1/8" = 1'-0"

1. BUILDING NO. 1 IS THOUGHT TO BE THE MAIN HOUSE.
2. ALL WALLS ARE PLASTERED. THE SOUTHEAST WALL IS COATED WITH TWO LAYERS OF PLASTER.
3. EVIDENCE OF 4" (.10m) DIAMETER WOODEN POST IN ALL MAIN CORNERS.
4. EVIDENCE OF PLASTER FLOOR IN MAIN AREA AND ON EAST SIDE OF MAIN AREA.
5. EVIDENCE OF LARGE WOODEN BEAM ON TOP OF NORTHEAST WALL (PLASTER HAS INDICATIONS OF WOODEN STRUCTURE.)
6. EVIDENCE OF WOOD FRAMING AND BEAMS IN WINDOWS. THREE APPROX. 3" (.08m) SQUARE BEAMS AT TOP OF WINDOW DOWELED INTO UPRIGHT WOODEN POST.
7. WALL FALLEN IN SITU NEAR DOOR IN SOUTHEAST WALL.
8. PIECE OF POTTERY FOUND WITHIN THE PLASTER IN SOUTHEAST WALL.

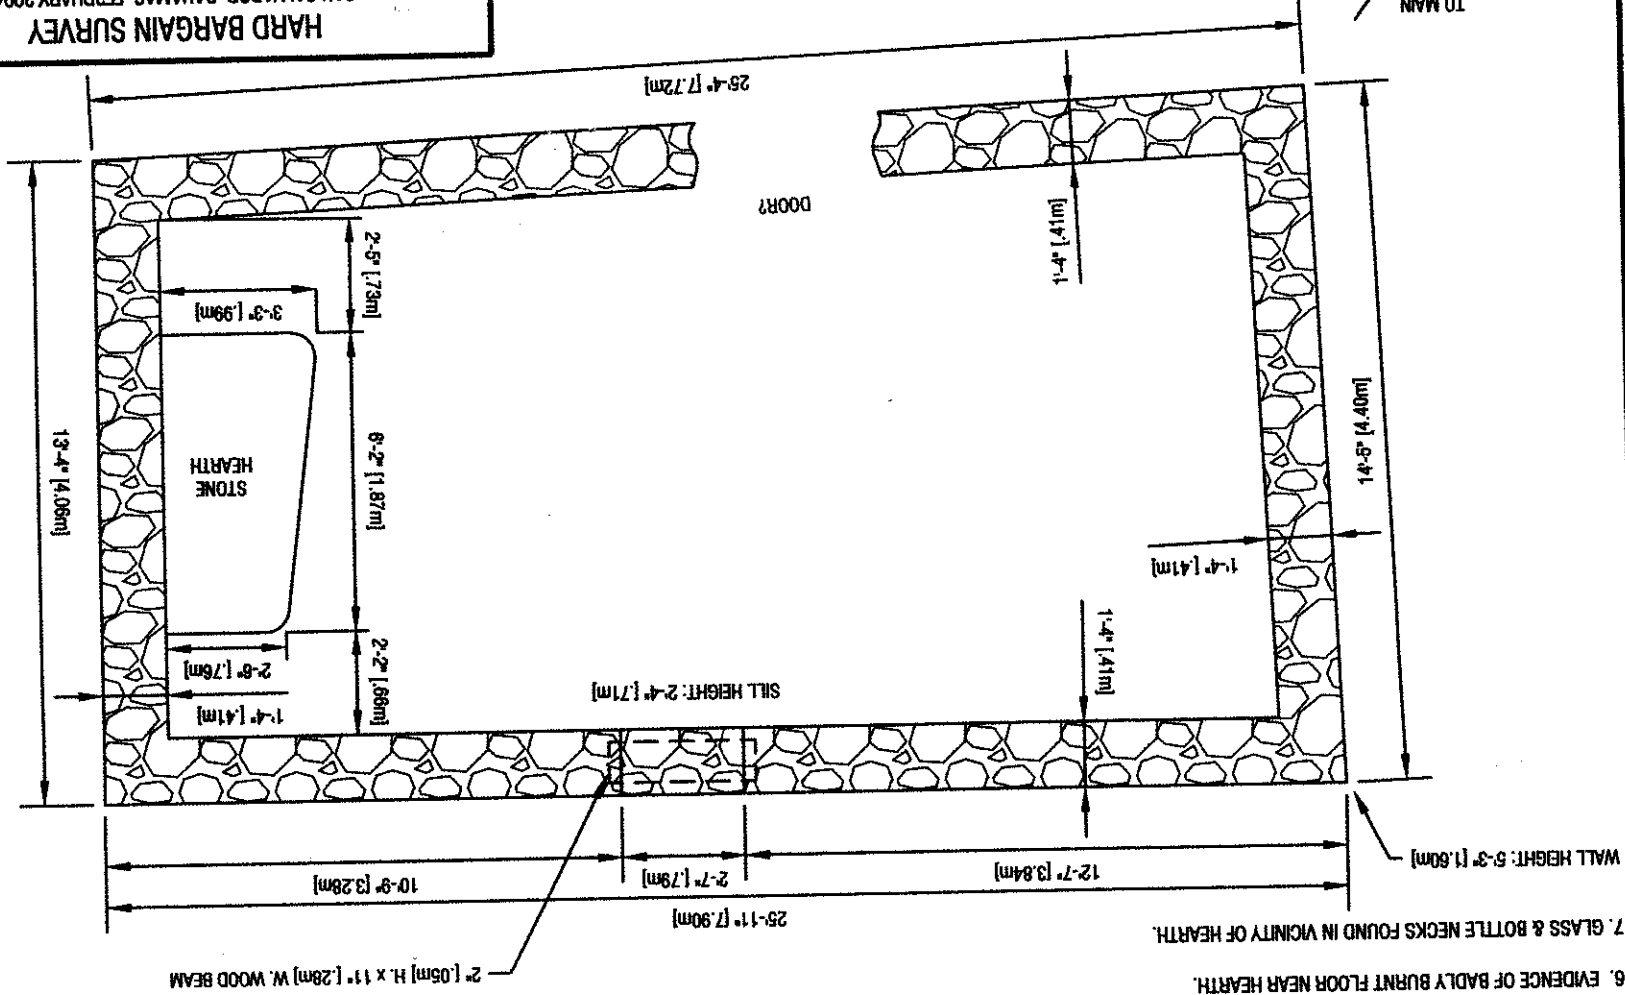
1. BUILDING NO. 2 IS THOUGHT TO BE THE COOK HOUSE.
2. WROUGHT IRON EYE BOLT FOUND UNDER WINDOW.
3. EVIDENCE OF PLASTER FLOOR IN SOUTH CORNER.
4. WALLS ARE PLASTERED.
5. EVIDENCE OF STONE HEARTH. EVIDENCE OF FIRE DUE TO SOOTY SOIL AND ASH.
6. EVIDENCE OF BADLY BURNT FLOOR NEAR HEARTH.
7. GLASS & BOTTLE NECKS FOUND IN VICINITY OF HEARTH.

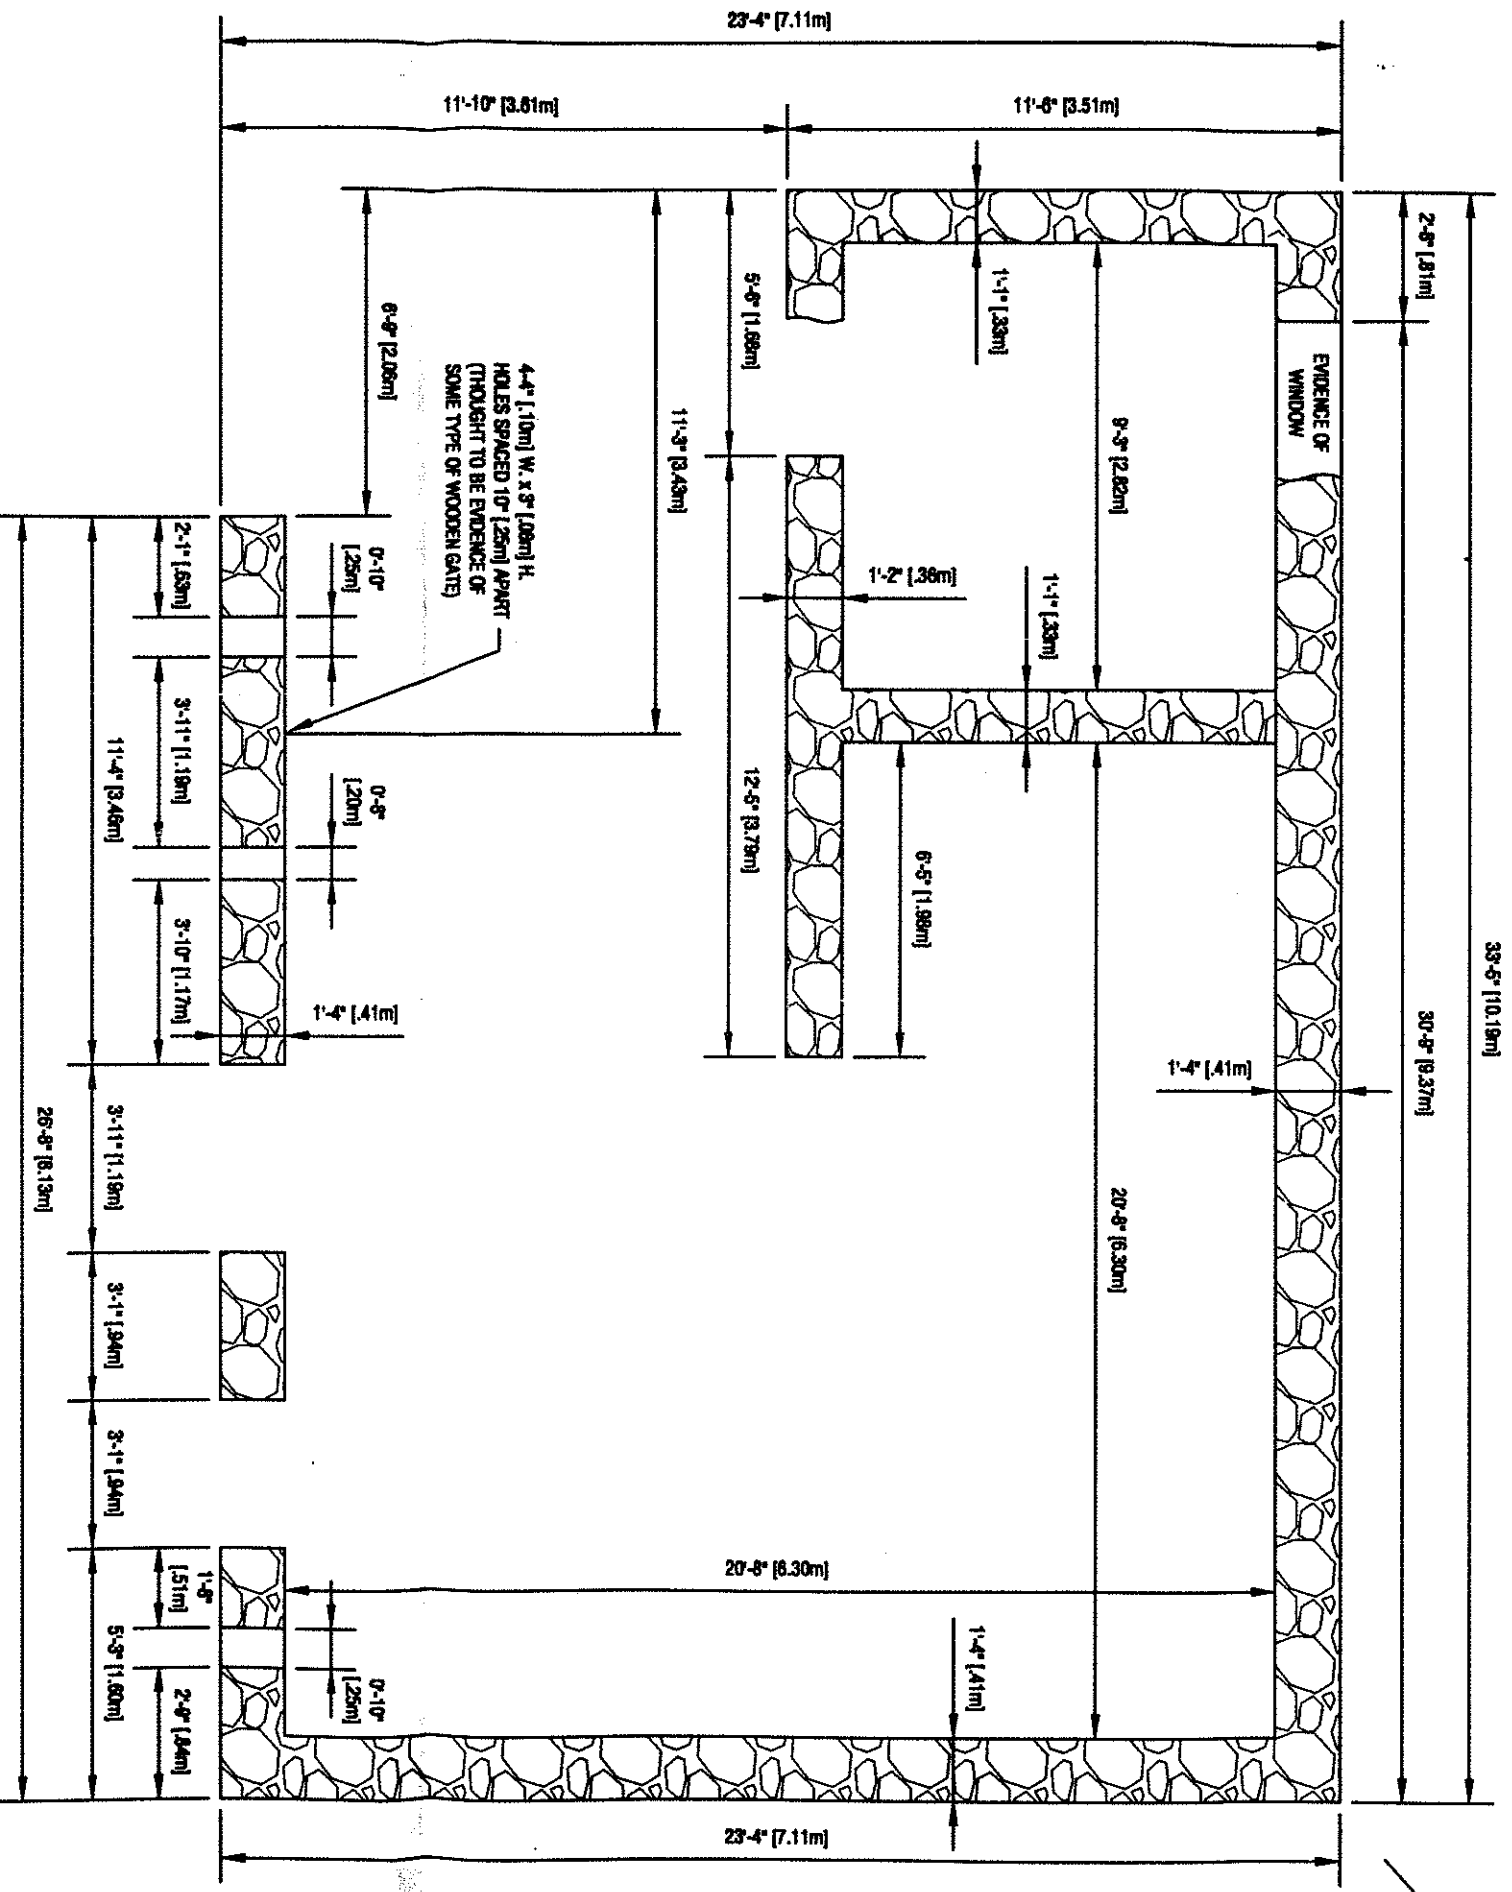
BUILDING NO. 4  
SCALE: 1/4" = 1'-0"

1. BUILDING NO. 4 IS THOUGHT TO BE THE STABLES.
2. SOUTHWEST WALL FALLEN IN SITU IS EVIDENCE THAT THE ENTIRE STRUCTURE WAS BUILT TO THE SAME HEIGHT AS THE NORTHEAST CORNER - APPROX. 6'-10" [2.08m].
3. EVIDENCE OF VENTILATION IN THE SOUTHEAST WALL - 3 OPENINGS NOT LARGE ENOUGH FOR A TYPICAL WINDOW.
4. EVIDENCE OF WOODEN DOOR FRAMES IN THE SOUTHEAST WALL.
5. EVIDENCE OF HOLES IN THE INTERIOR OF THE SOUTHEAST WALL THAT MAY HAVE BEEN USED TO SUPPORT WOOD BEAMS IN ORDER TO FORM A GATE.
6. EVIDENCE OF WOOD FRAME FOR A POSSIBLE DOOR OR WINDOW IN WEST CORNER.
7. EVIDENCE OF A PLASTER FLOOR WAS FOUND IN THE SOUTHWEST CORNER OF THE STRUCTURE.

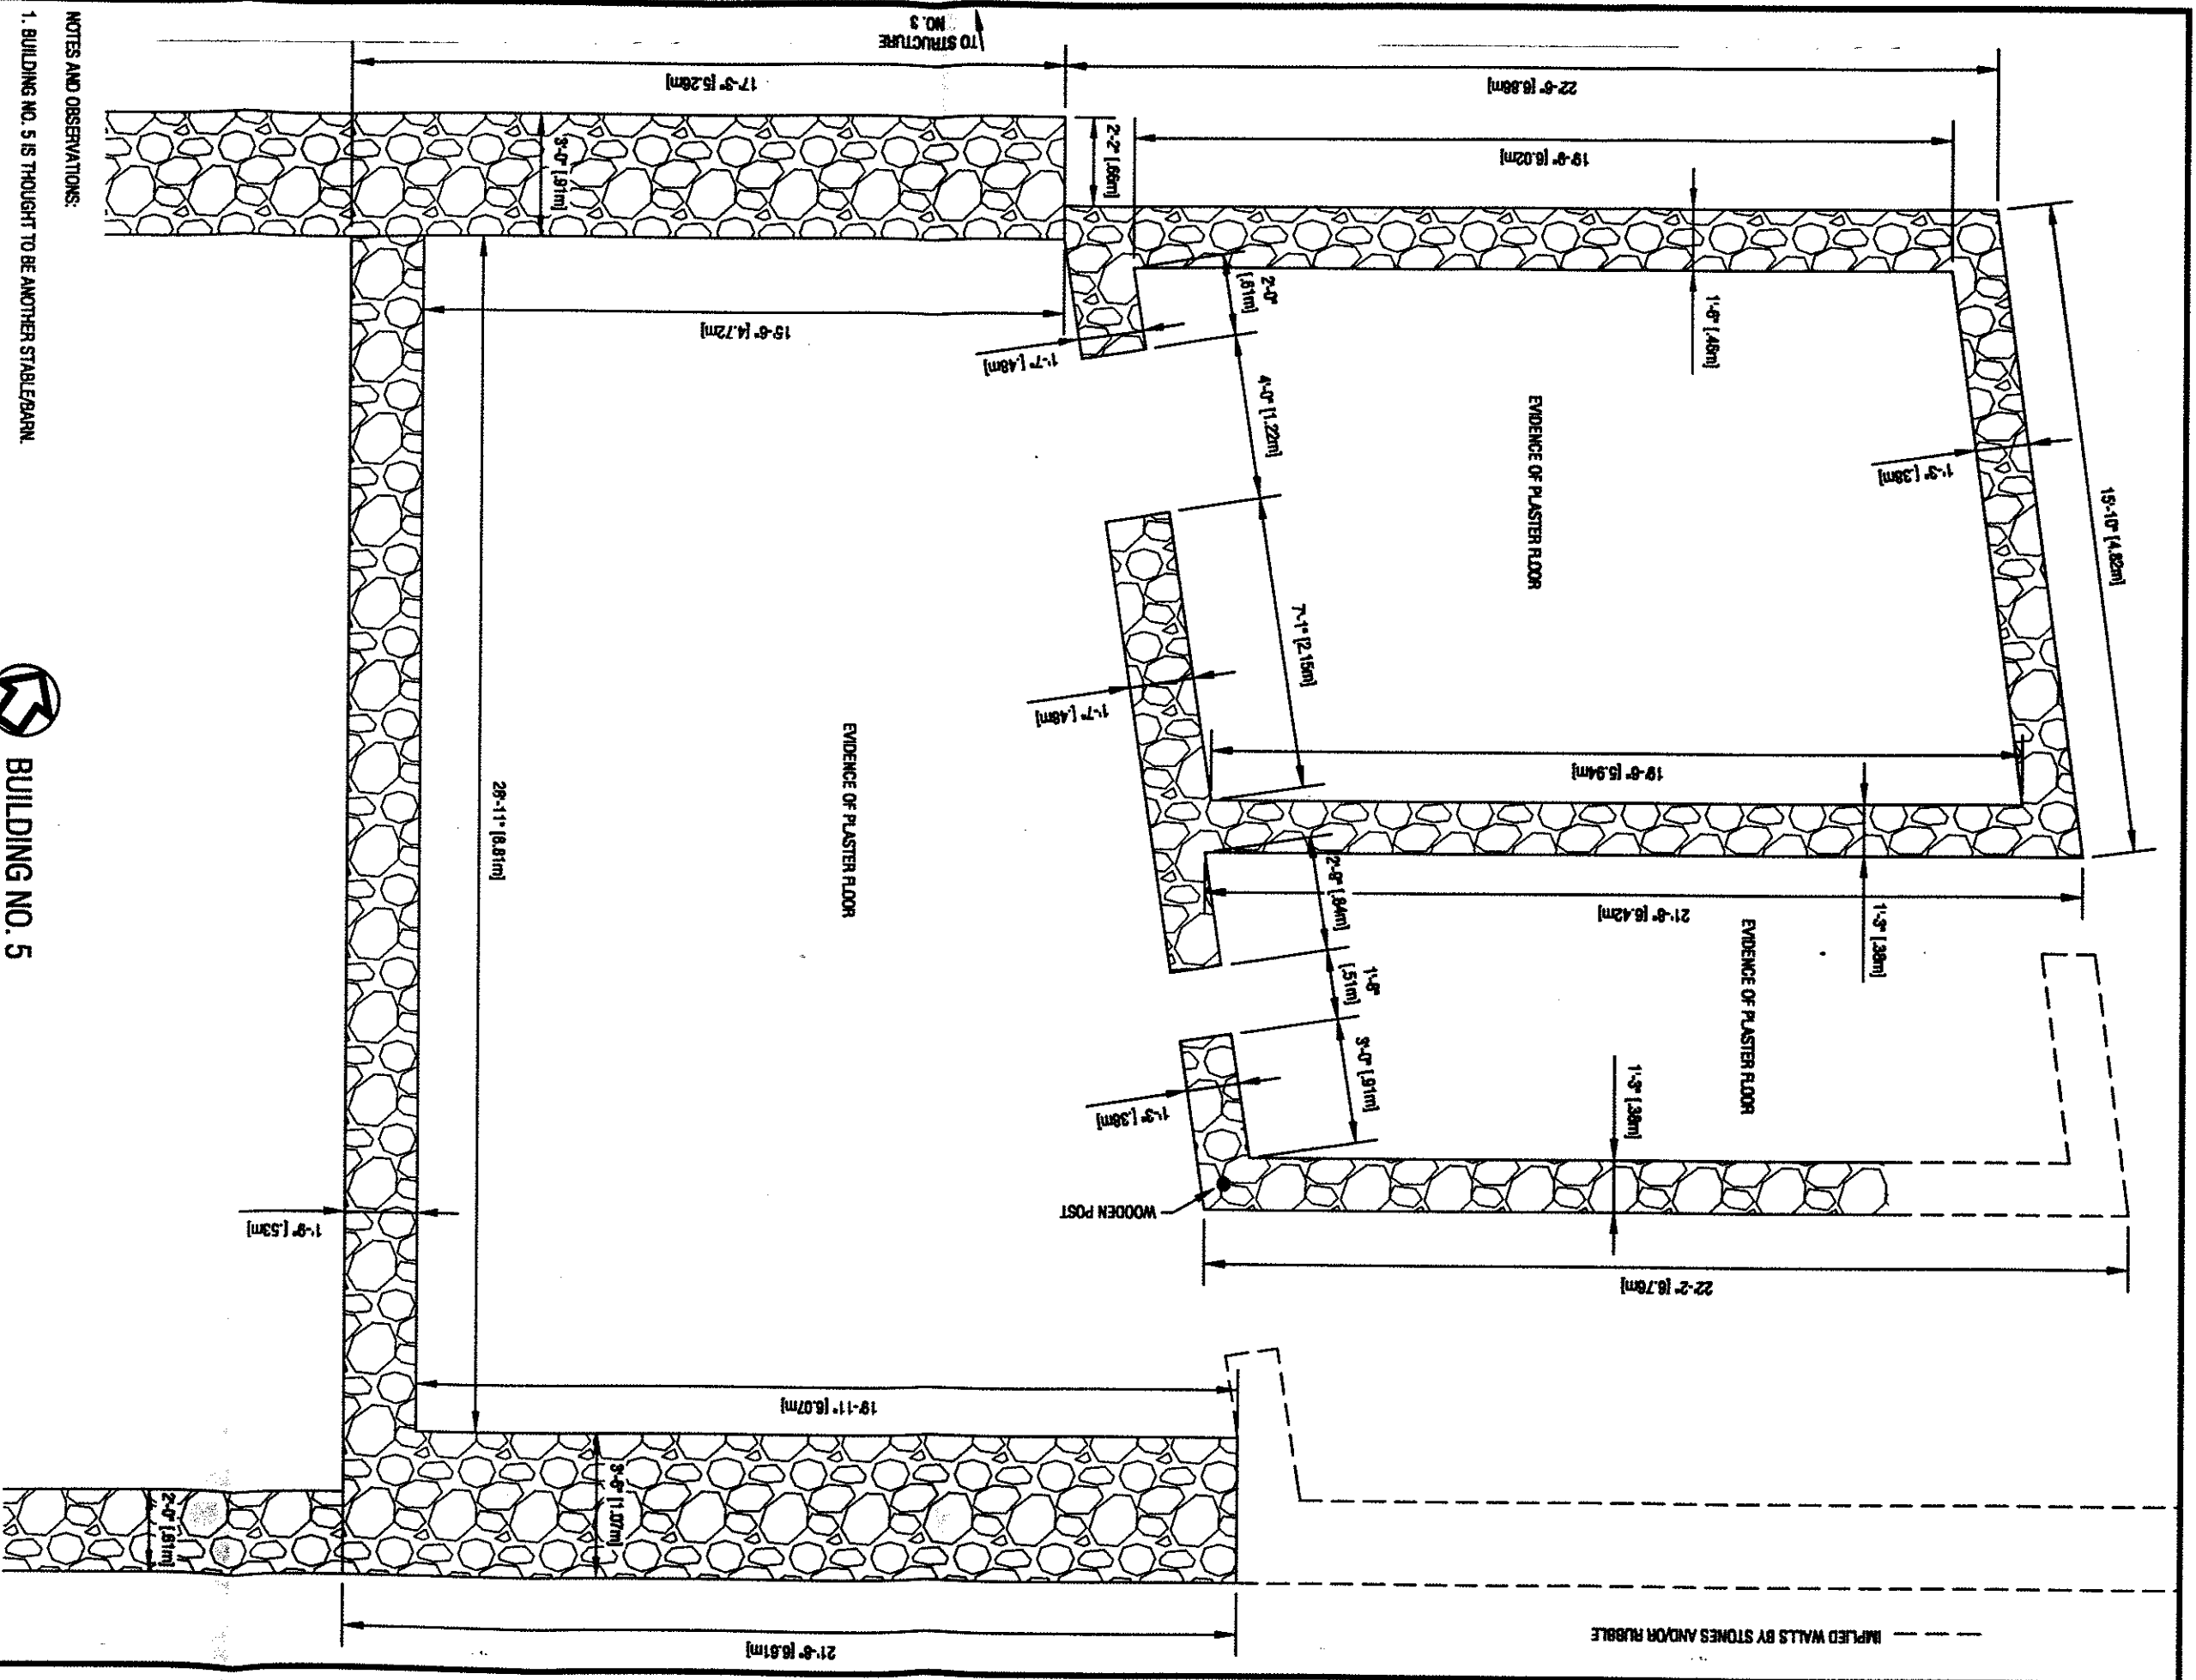
**BUILDING NO. 5**  
SCALE: 1/4" = 1'-0"

1. BUILDING NO. 5 IS THOUGHT TO BE ANOTHER STABLE/BARN
2. SOUTHWEST WALL: WALL IS PLASTERED WITH TWO DIFFERENT TYPES OF PLASTER, ONE FROM FLOOR TO HALFWAY UP THE WALL, THE OTHER FROM HALFWAY UP THE WALL TO THE TOP.
3. EVIDENCE OF DOOR SILLS AND DOOR FRAMES (SQUARE EDGES IN PLASTER) IN DIAGONAL WALL.
4. EVIDENCE OF PLASTER FLOOR IN SOME PARTITIONED ROOMS.
5. 4" (1.0m) DIAMETER WOODEN POST IN CORNER OF WALL.
6. THE LARGE WALLED AREA IS AT HIGHER ELEVATION THAN THE REMAINING AREAS. MUST STEP DOWN.
7. ALL FLOORS APPEAR TO BE AT DIFFERENT LEVELS.

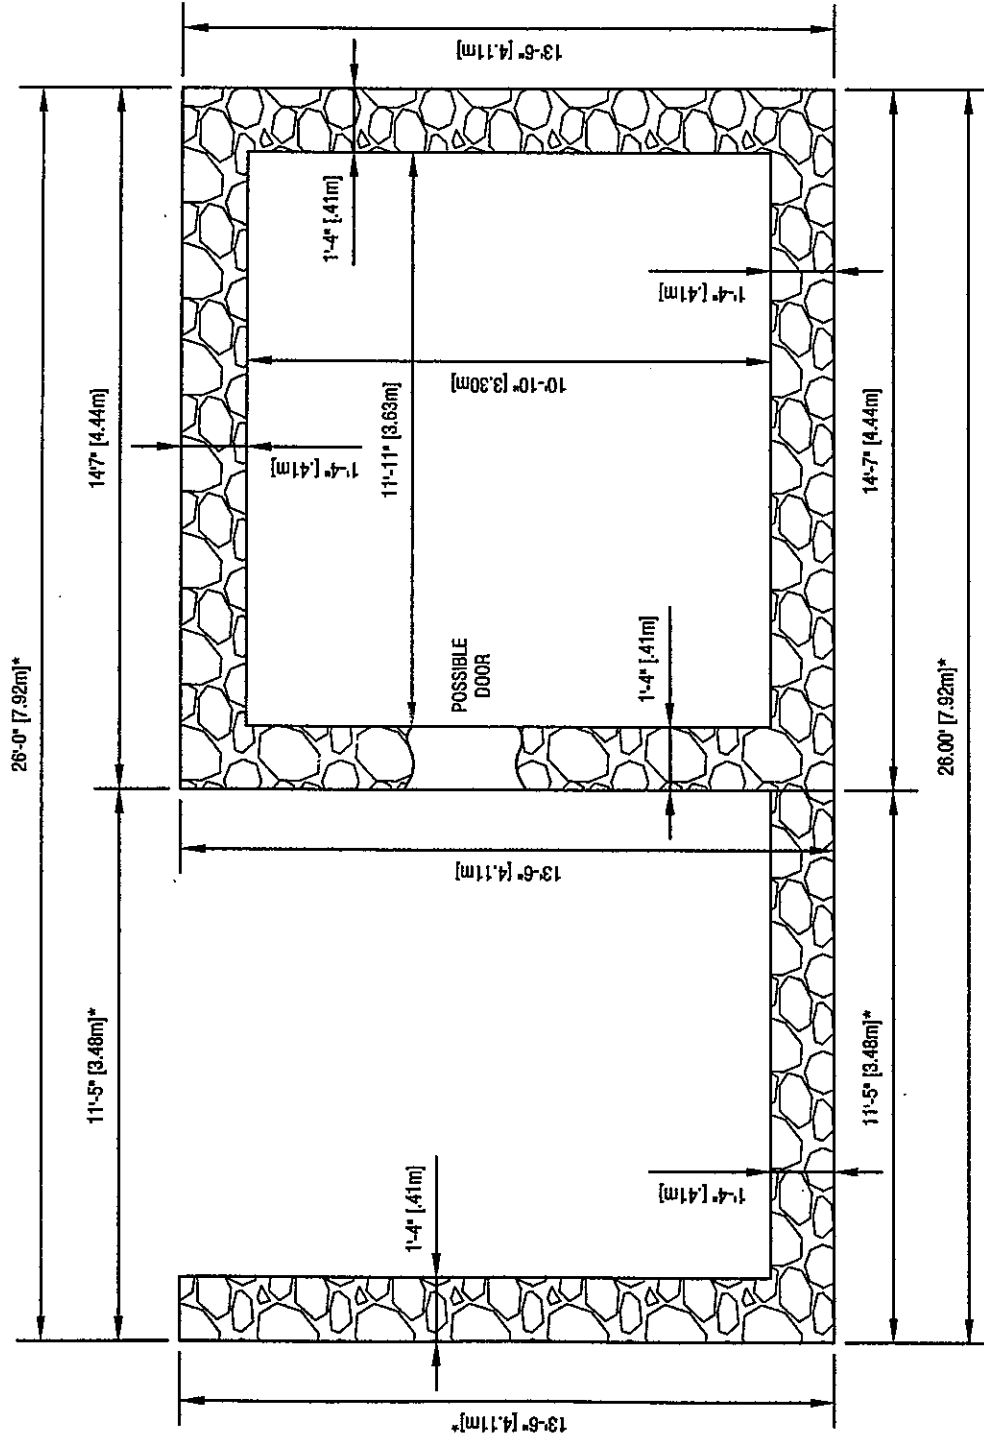
**SLAVE HOUSE NO. 2**  
SCALE: 1/4" = 1'-0"

\* APPROXIMATE DIMENSIONS. WALL IS EVIDENT BUT NOT WELL DEFINED.

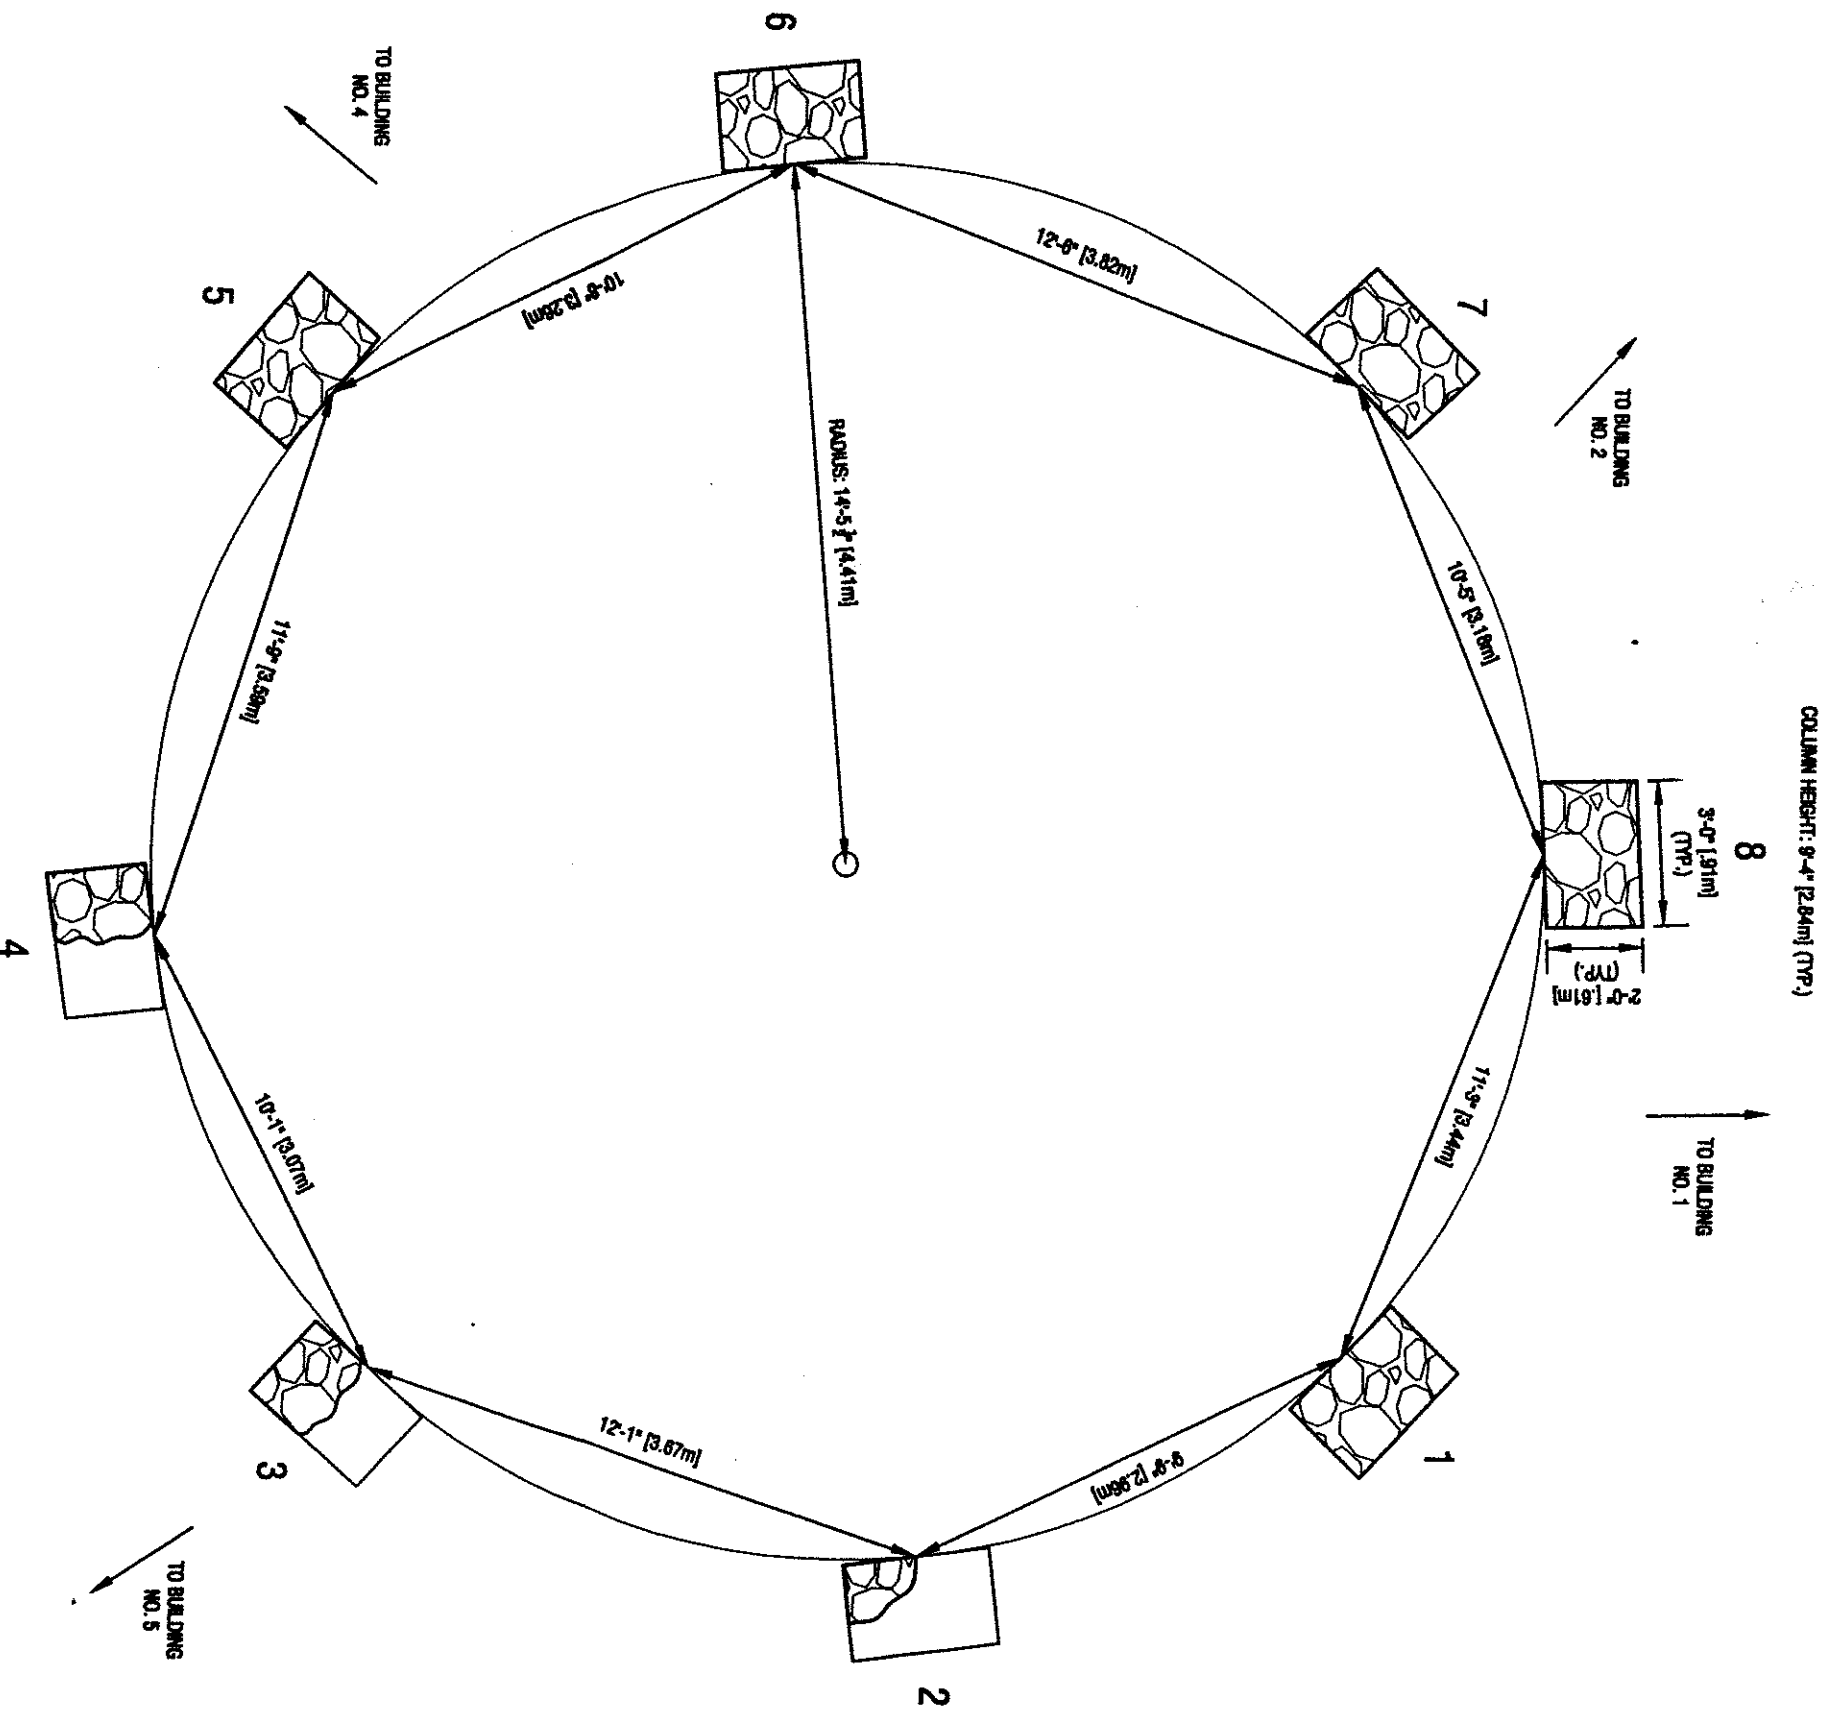
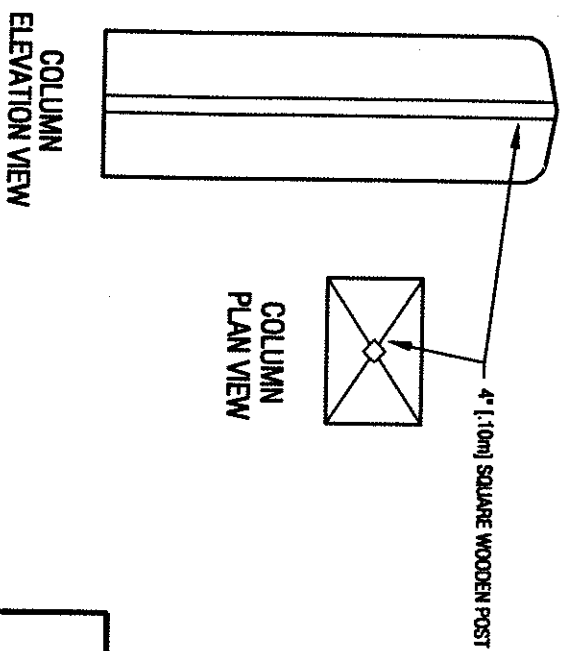
STRUCTURE NO. 3  
SCALE: 1/4" = 1'-0"

1. STRUCTURE NO. 3 IS THOUGHT TO BE THE GAMING CIRCLE.
2. COLUMNS WERE PLASTERED.
3. EVIDENCE THAT COLUMNS WERE PAINTED RED/PINK.
4. EVIDENCE OF APPROXIMATELY 4" [1.0m] SQUARE WOODEN POST INSIDE EACH COLUMN.
5. TOP OF COLUMNS HAD CURVED DETAIL. (SEE DETAIL RIGHT.)
6. NUMEROUS COLUMNS HAD HOLES IN VARIOUS LOCATIONS. ALL WERE APPROXIMATELY THE SAME SIZE: 2.5" [0.6m] SQUARE.
7. COLUMNS 1 THROUGH 5 AND 8 HAD VISIBLE HOLES AS DESCRIBED ABOVE:
  - a. COLUMN 1: HOLE THROUGH ENTIRE COLUMN
  - b. COLUMN 4: HOLE FROM OUTSIDE TO MIDDLE OF COLUMN
  - c. COLUMN 5: HOLE FROM INSIDE TO MIDDLE OF COLUMN
  - d. COLUMN 8: HOLE FROM INSIDE TO MIDDLE OF COLUMN
 HOLES ARE THOUGHT TO BE USED FOR SUPPORT STRUCTURES.
8. COLUMNS 2, 3 AND 4 ARE PARTIALLY IN PLACE AS INDICATED.
