**HARD BARGAIN SURVEY**  
SAN SALVADOR, BAHAMAS, FEBRUARY 2004  
PREPARED BY: CARIBBEAN VOLUNTEER EXPEDITIONS (C/VE)  
VOLUNTEERS: S. RICE, A. AS CALLAWAN, R. GARBARK,  
R. HIRSCHMAN, J. MILLER, E. AM. ROBERTS, J. WILKINDE

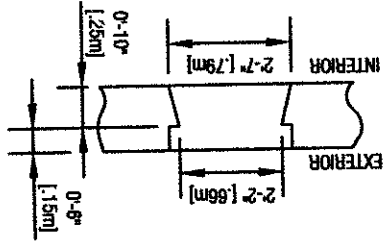
1. BUILDING NO. 2 IS THOUGHT TO BE THE COOK HOUSE.
2. WROUGHT IRON EYE BOLT FOUND UNDER WINDOW.
3. EVIDENCE OF PLASTER FLOOR IN SOUTH CORNER.
4. WALLS ARE PLASTERED.
5. EVIDENCE OF STONE HEARTH. EVIDENCE OF FIRE DUE TO SOOTY SOIL AND ASH.
6. EVIDENCE OF BADLY BURNT FLOOR NEAR HEARTH.
7. GLASS & BOTTLE NECKS FOUND IN VICINITY OF HEARTH.

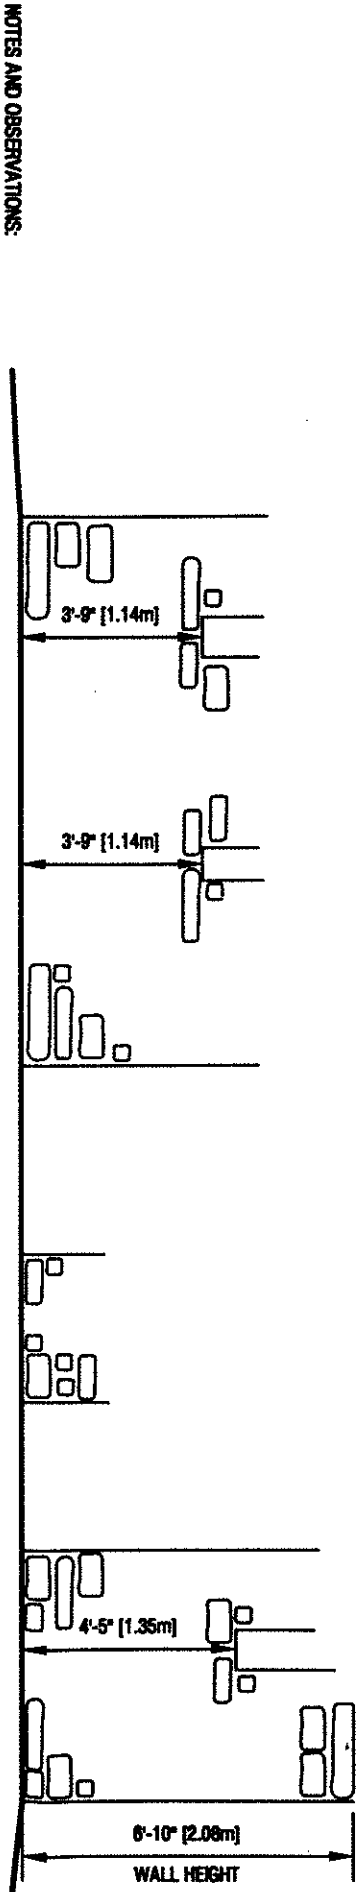
BUILDING NO. 4  
SCALE: 1/4" = 1'-0"

1. BUILDING NO. 4 IS THOUGHT TO BE THE STABLES.
2. SOUTHWEST WALL FALLEN IN SITU IS EVIDENCE THAT THE ENTIRE STRUCTURE WAS BUILT TO THE SAME HEIGHT AS THE NORTHEAST CORNER - APPROX. 6'-10" [2.08m].
3. EVIDENCE OF VENTILATION IN THE SOUTHEAST WALL - 3 OPENINGS NOT LARGE ENOUGH FOR A TYPICAL WINDOW.
4. EVIDENCE OF WOODEN DOOR FRAMES IN THE SOUTHEAST WALL.
5. EVIDENCE OF HOLES IN THE INTERIOR OF THE SOUTHEAST WALL THAT MAY HAVE BEEN USED TO SUPPORT WOOD BEAMS IN ORDER TO FORM A GATE.
6. EVIDENCE OF WOOD FRAME FOR A POSSIBLE DOOR OR WINDOW IN WEST CORNER.
7. EVIDENCE OF A PLASTER FLOOR WAS FOUND IN THE SOUTHWEST CORNER OF THE STRUCTURE.

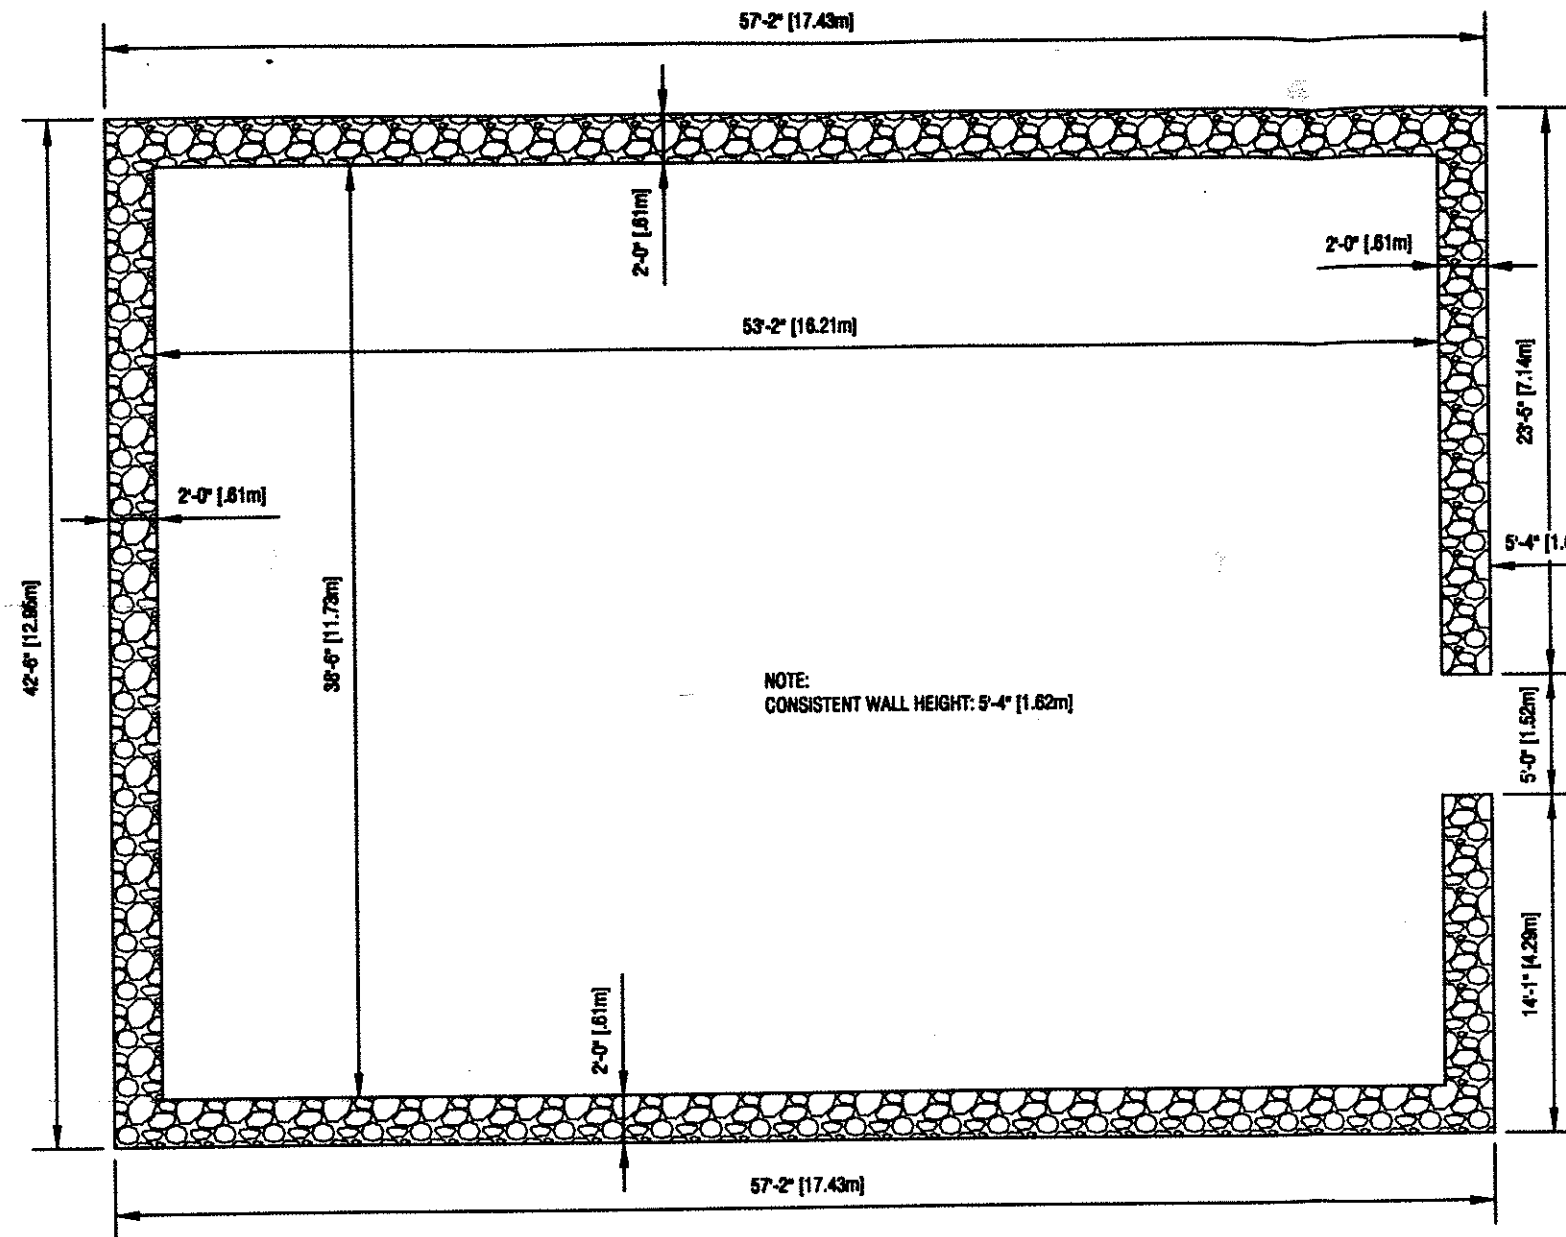
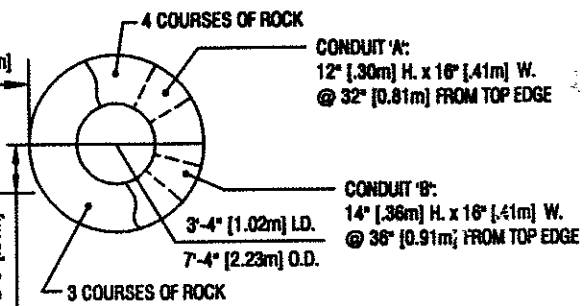
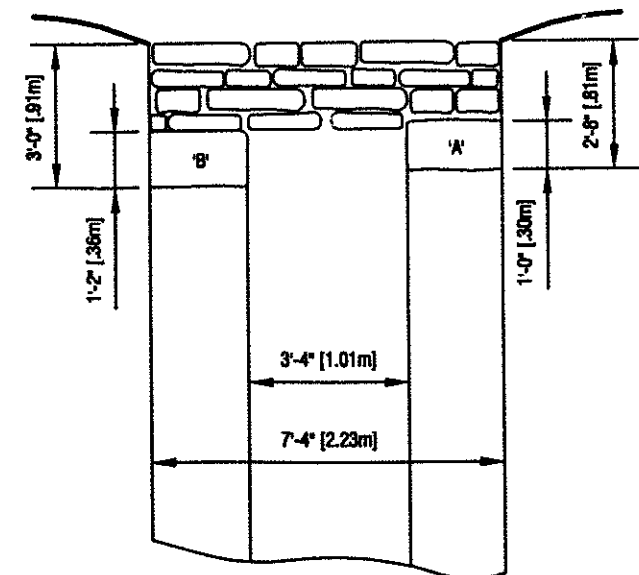
PEN & WELL  
SCALE: 1/8" = 1'-0"

NOTE:  
WELL DEPTH UNKNOWN

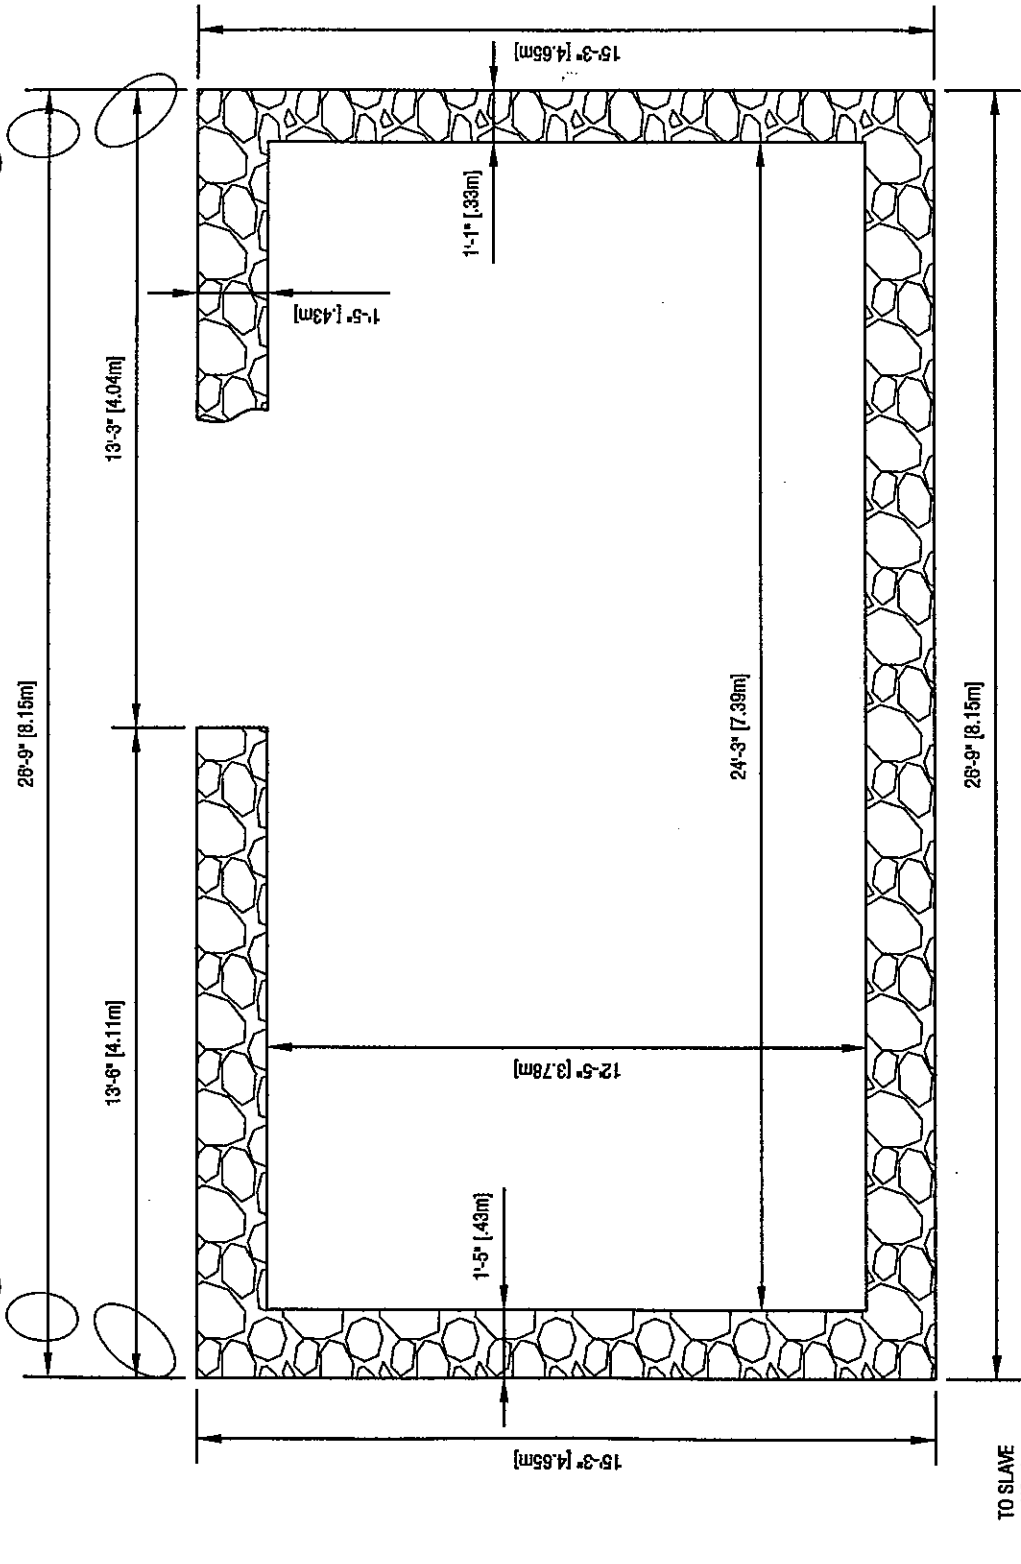
**SLAVE HOUSE NO. 5**

NOTE: RANDOM ROCKS FORMING A DISTINGUISHABLE SEMI-CIRCLE EXTENDING TO THE NORTHWEST
